SCOUR ANALYSIS REPORT **Pedestrian Footbridge over Branch Brook**

BL Project No. 1800579

Naugatuck River Greenway Multi-Use Trail
Towns of Watertown and Thomaston, CT

HYDROLOGIC ANALYSIS REPORT Pedestrian Footbridge over Branch Brook

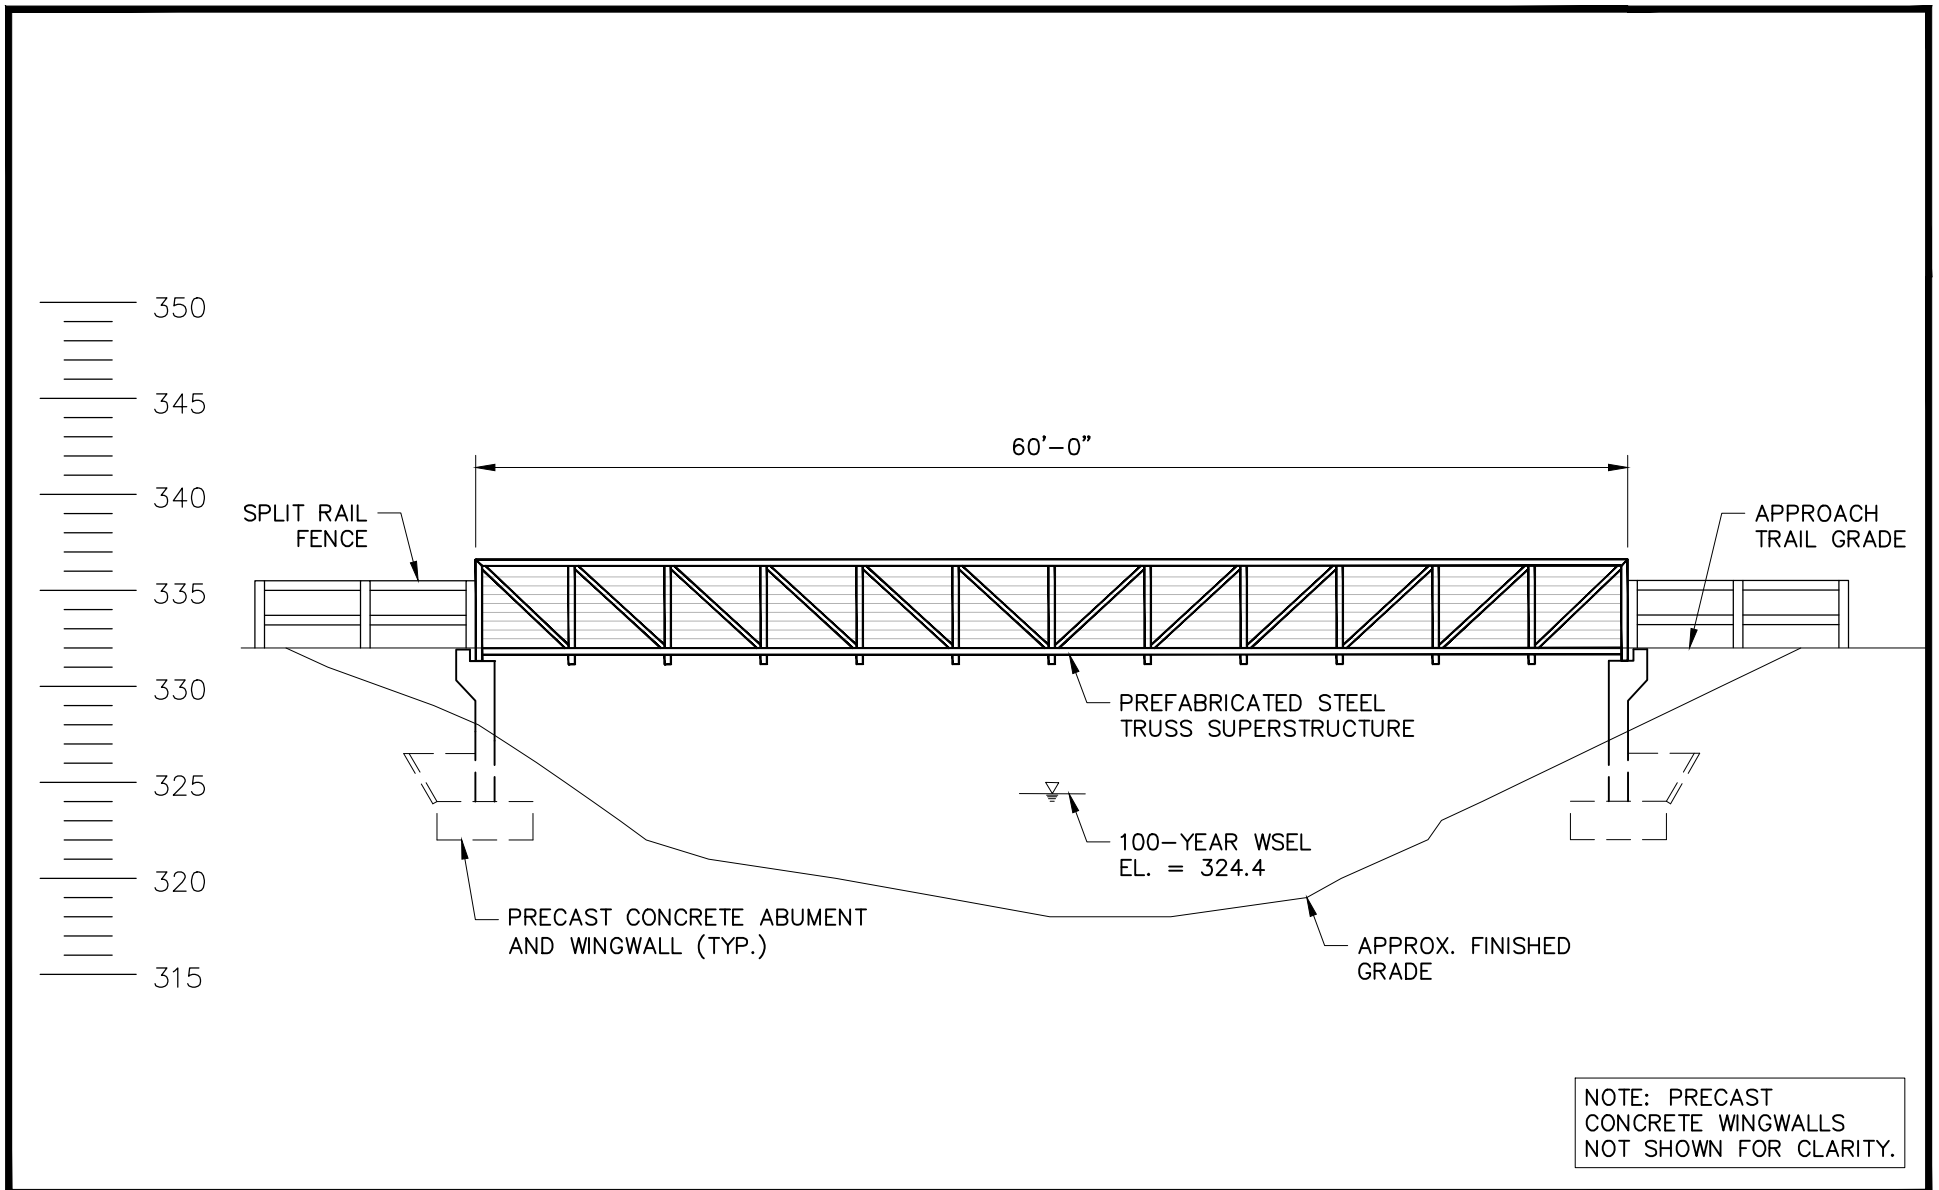
ALTERNATIVE 1 - DOWNSTREAM ELEVATION

Alternative 1 proposes building a prefabricated steel truss supported with reinforced concrete abutments and wingwalls. The new bridge will have a clear span of 60 ft and a low chord elevation of 331.25 ft. The bridge will have an approximate hydraulic opening area of 4,040 sq. ft.

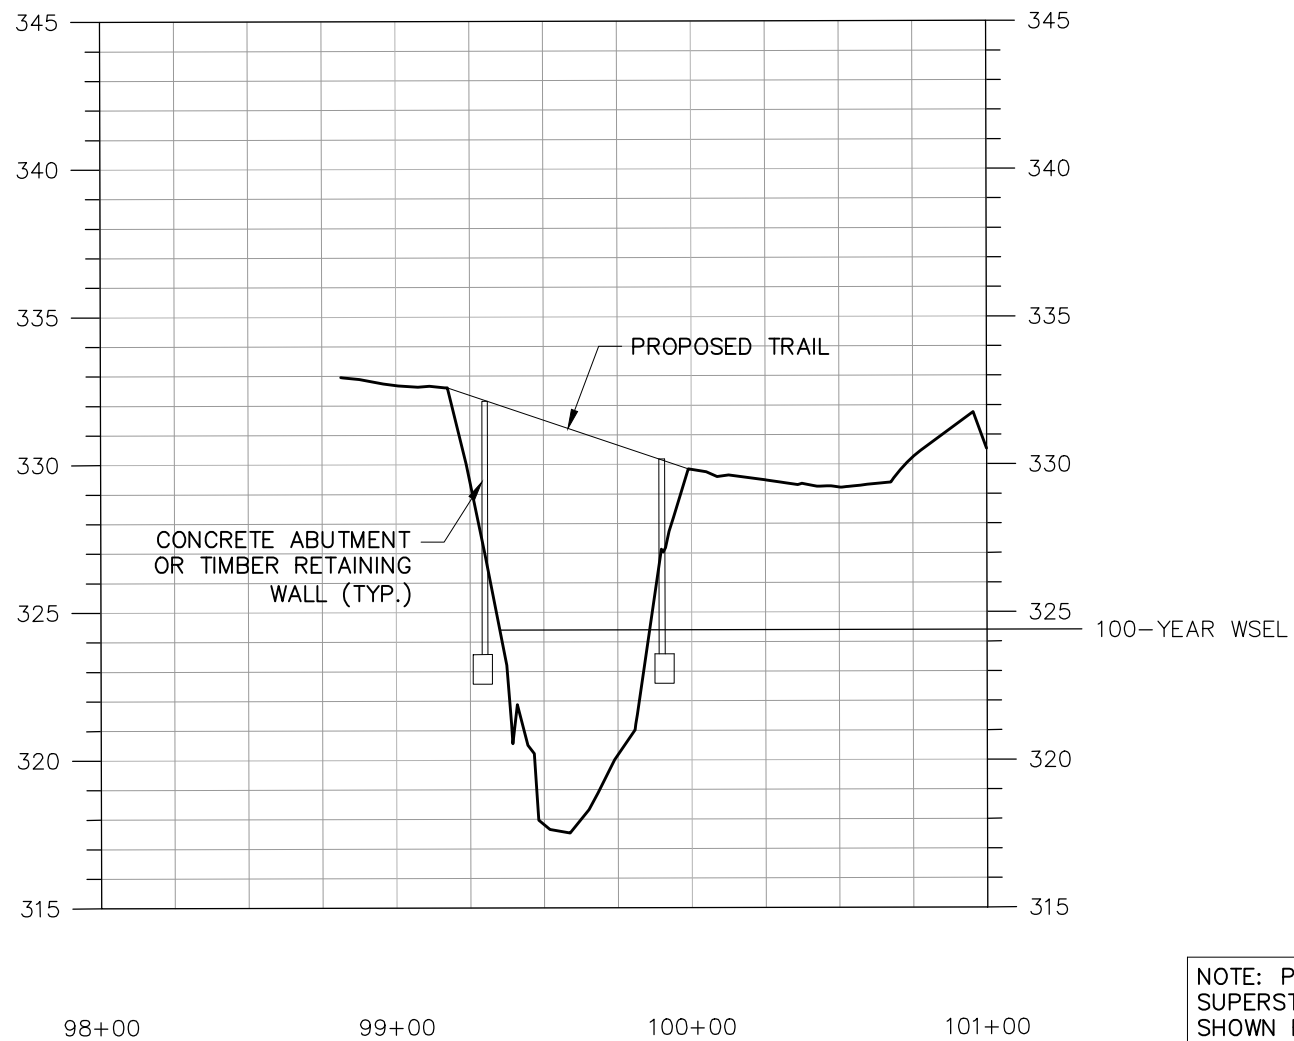
FIG. 7

PROFILE
 NAUGATUCK RIVER GREENWAY PEDESTRIAN
 BRIDGE OVER BRANCH BROOK
 THOMASTON, CONNECTICUT

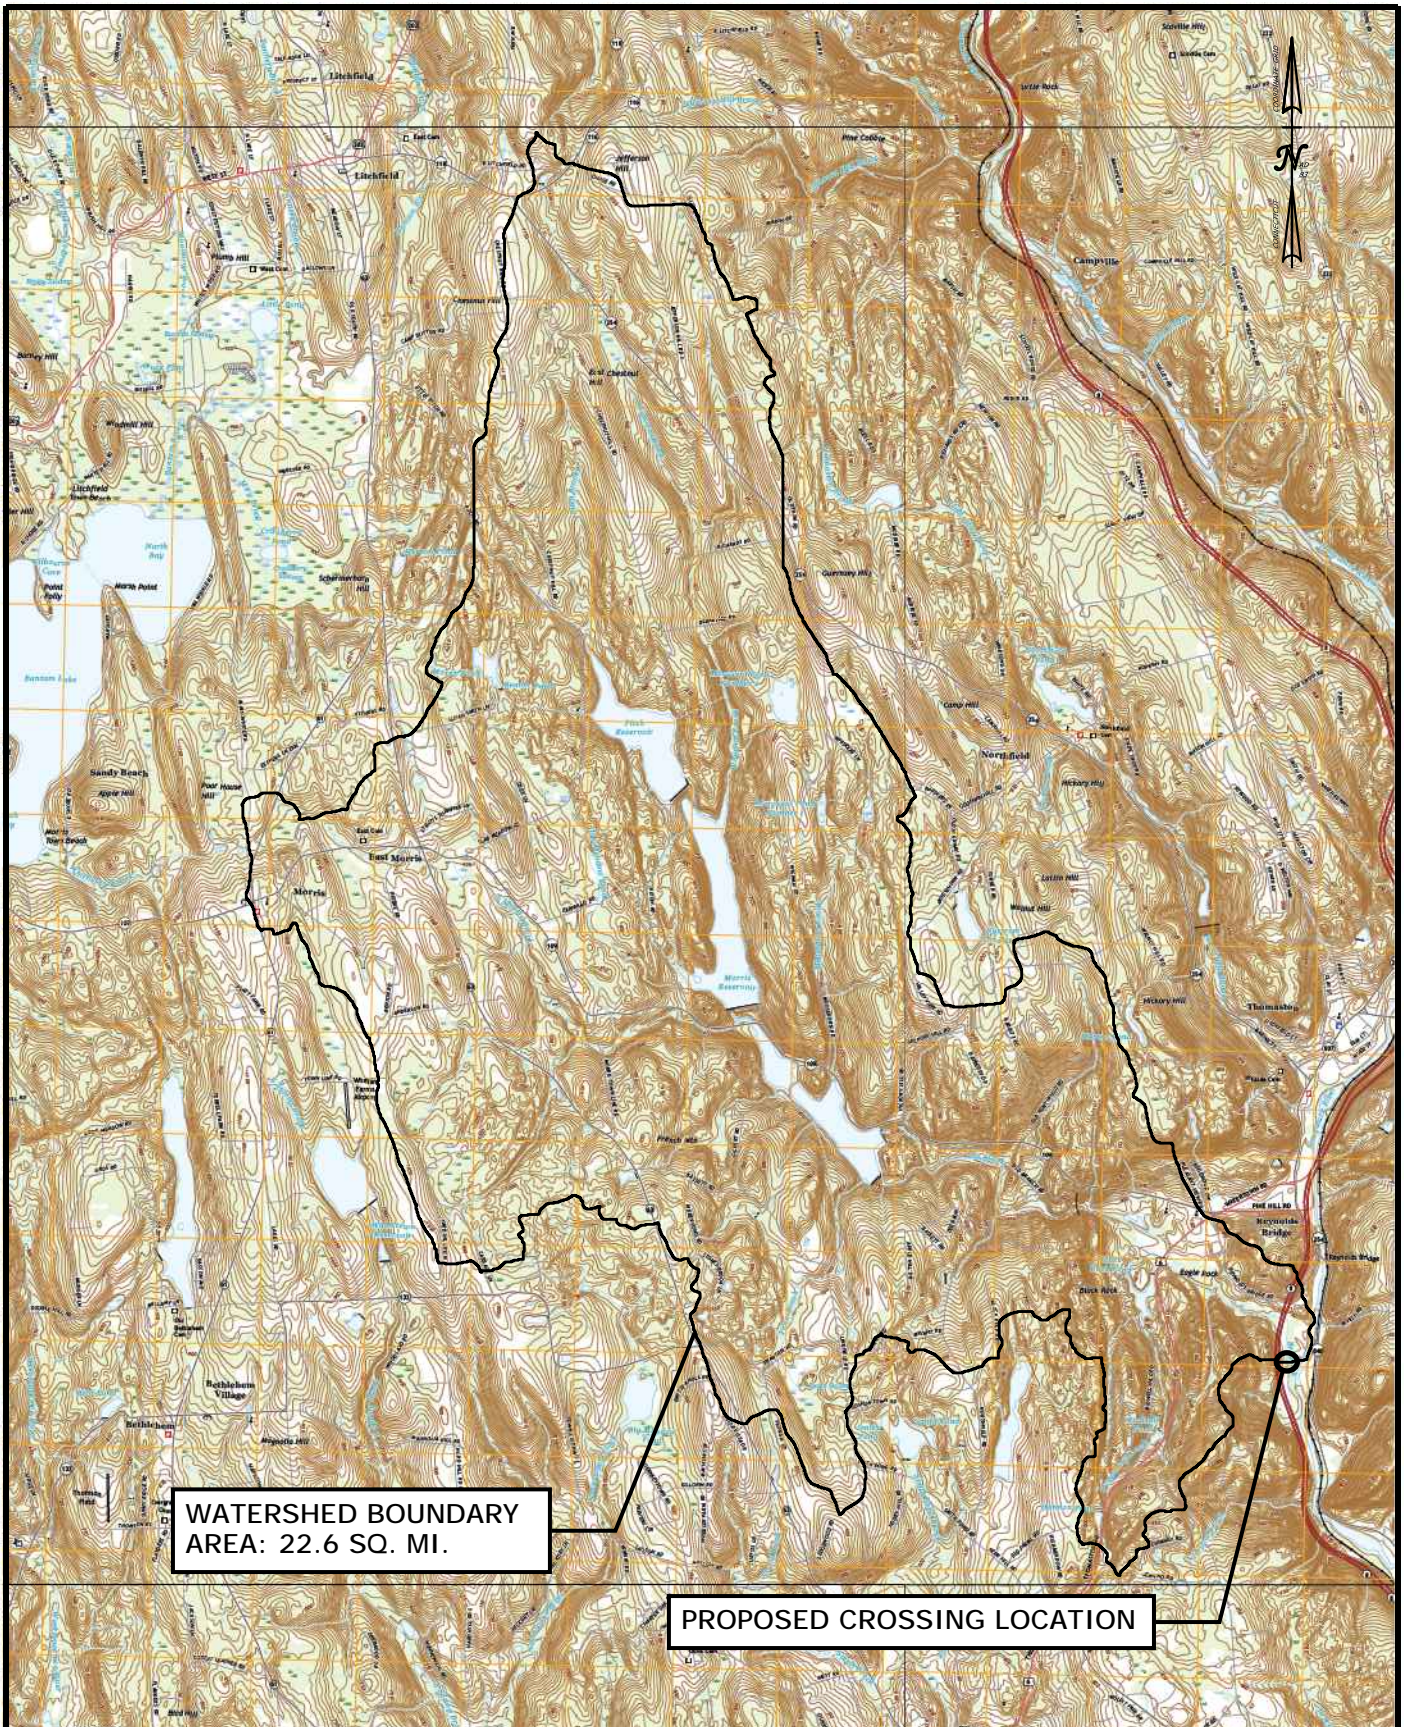
WATERSHED BOUNDARY
MAP

The river upstream of the bridge has an average streambed slope of 29.3 ft/mi. At the site of the proposed bridge, the brook has a drainage area of approximately 22.6 square miles. The watershed was generated by the USGS StreamStats 4.2 online application and revised for accuracy using USGS Quadrangle Maps from the National Map online viewer (see Figure 2). Utilizing the USGS StreamStats online utility, the watershed area exhibits that 9.69% of the land use is developed, 1.07% is wetlands and the remainder is forested or other pervious area. Delineation of surficial materials indicates that approximately 2.21% of the watershed area consists of coarse-grained stratified drift (see Figure 3) and the remainder is composed of various postglacial deposits and till.

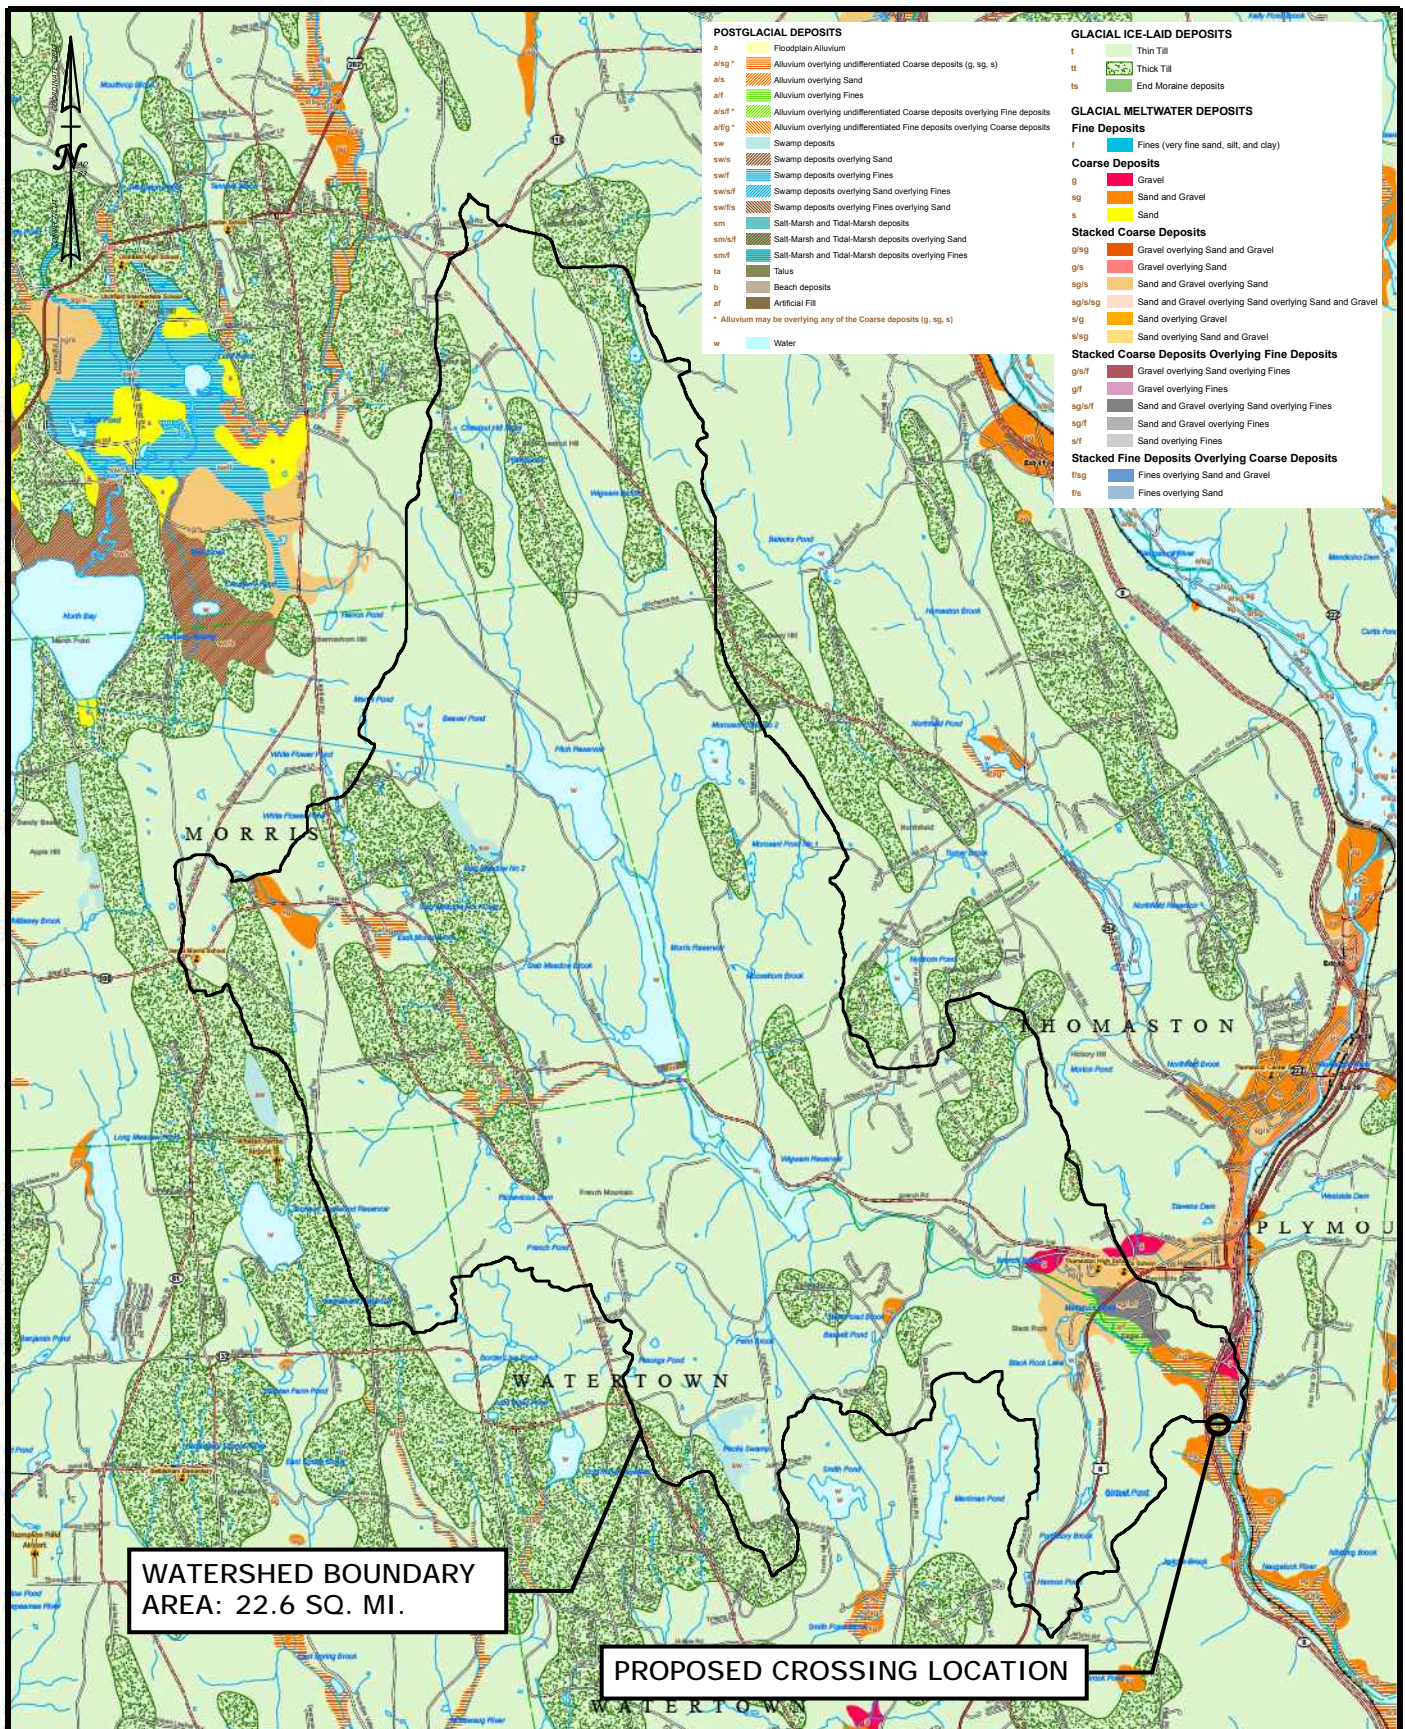
SURFICIAL MATERIALS MAP
